**BLACKSTONE RIVER BASIN
MILLBURY, MASSACHUSETTS**

**RAMSHORN POND DAM
MA 00145**

PHASE I INSPECTION REPORT NATIONAL DAM INSPECTION PROGRAM

JULY 1978

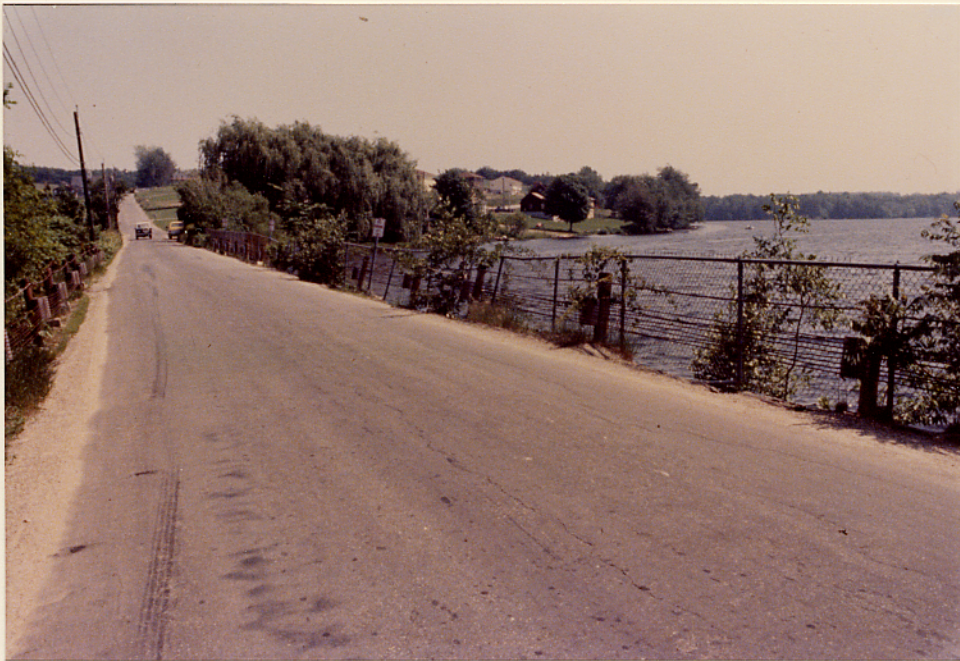
**OVERVIEW
RAMSHORN POND DAM
MILLBURY, MASSACHUSETTS**

DAM CREST (DOLAN ROAD) AND RAMSHORN POND

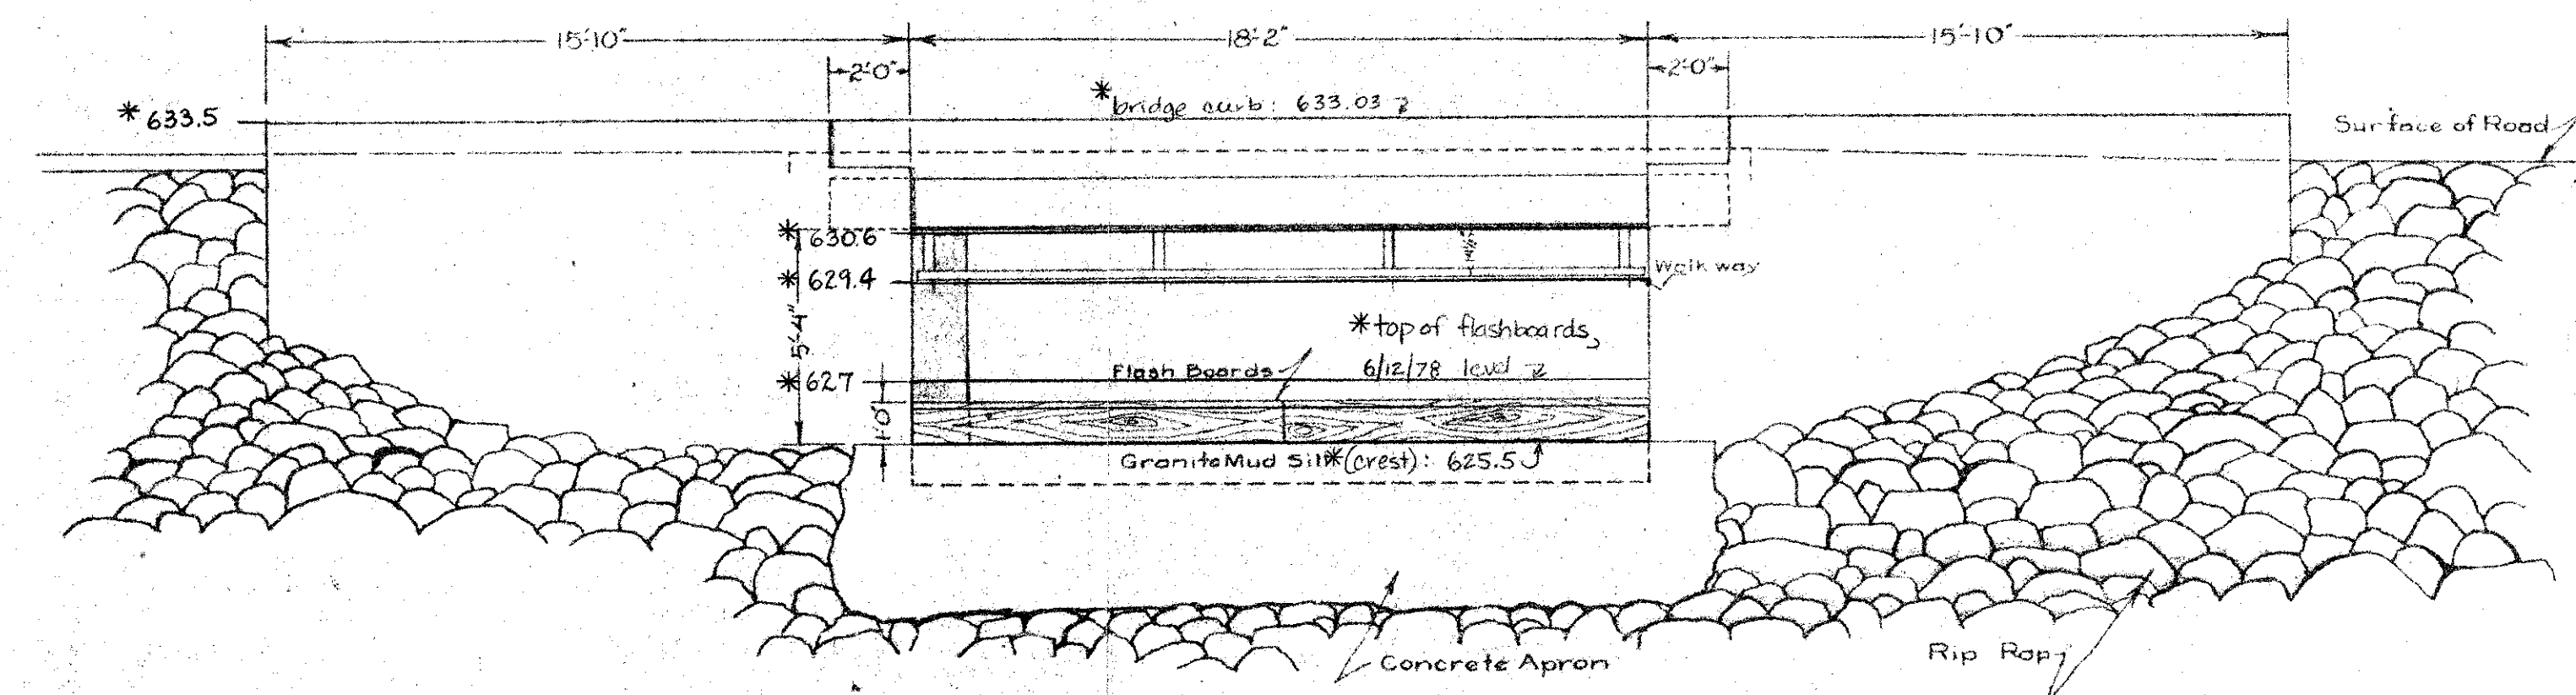
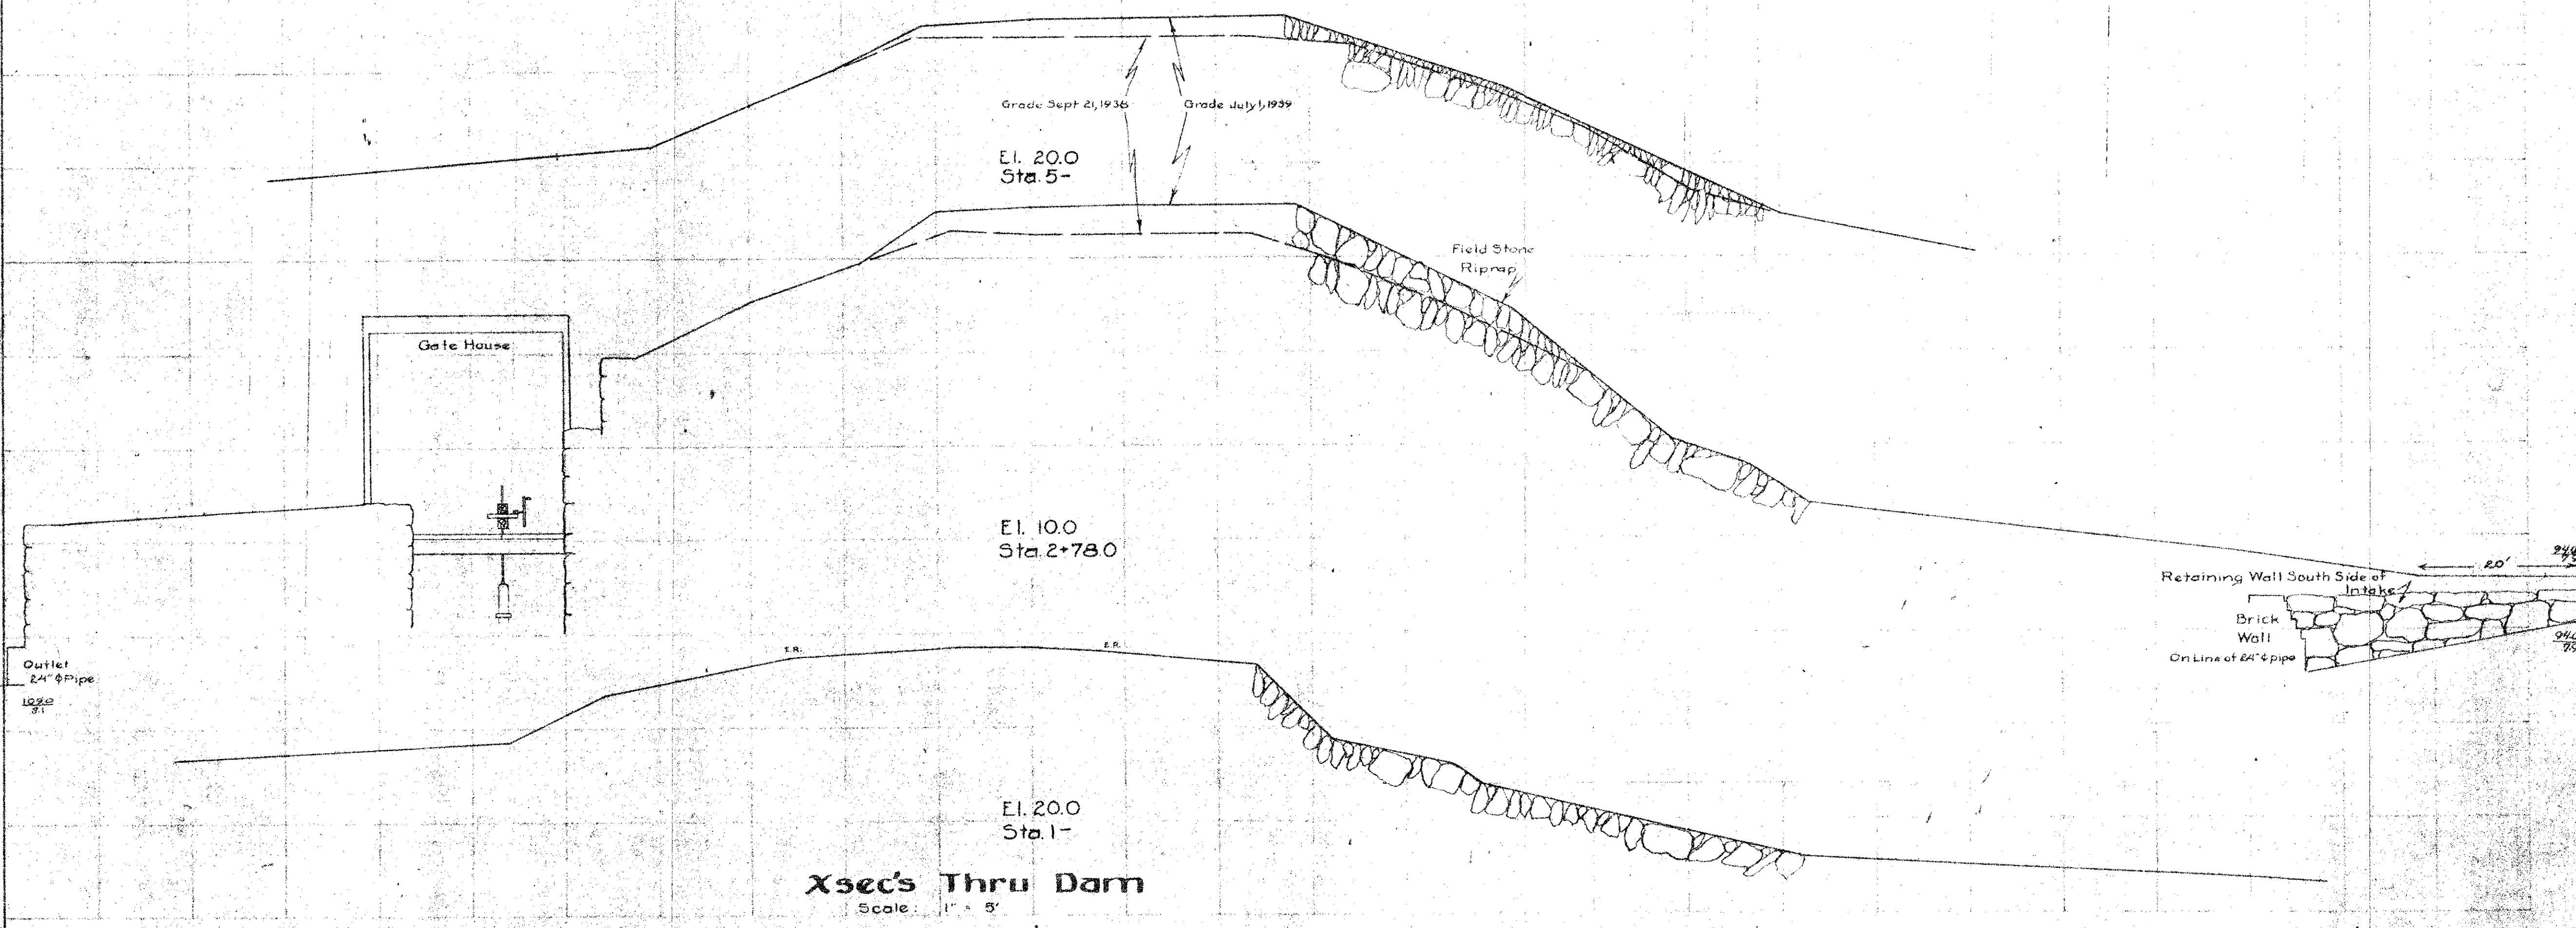
FIGURE B-3

- d. Overtopping Potential. Overtopping of the dam is barely expected under an inflow test flood of 2,040 cfs; as noted previously, however, the records on overtopping indicate that the dam was overtopped during the 1938 flood but was not overtopped in 1955. Figures B-2 and B-3 in Appendix B show the dam was raised about 2 feet in 1939.
